AIRCRAFT ACCIDENT REPORT

**PAN AMERICAN WORLD AIRWAYS
BOEING 747, N 737 PA**

**KLM ROYAL DUTCH AIRLINES
BOEING 747, PH-BUF**

HUMAN FACTORS REPORT

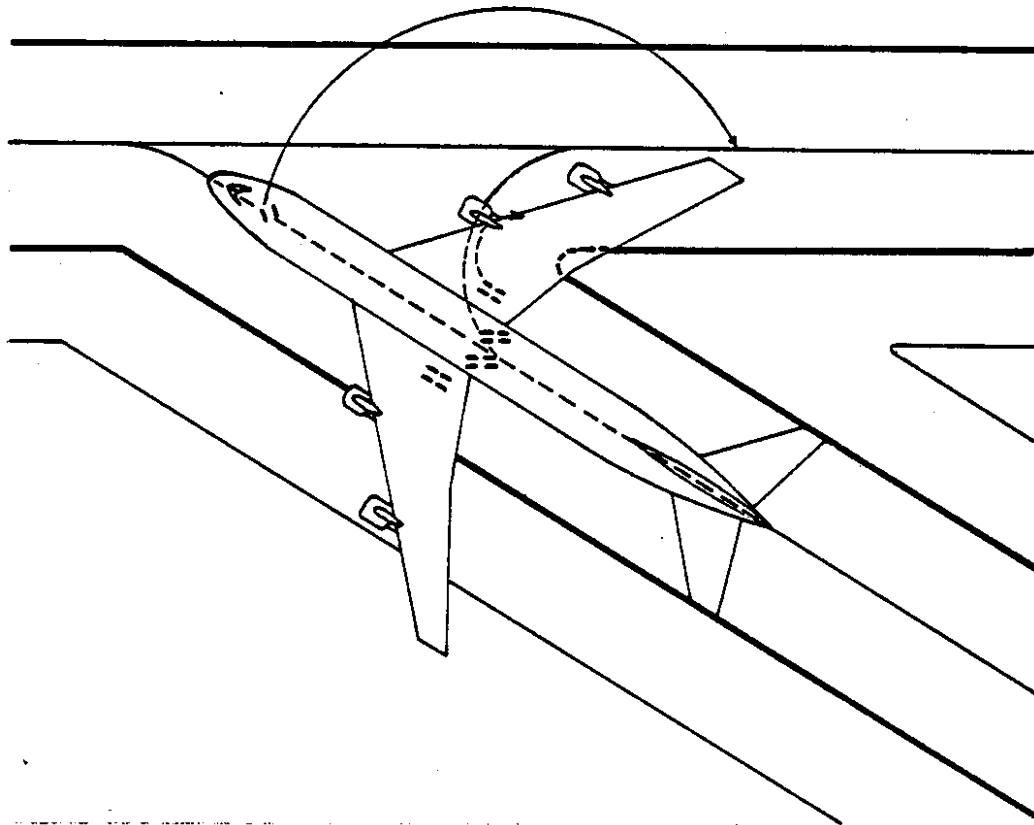
The Transition From Charlie Three

It was mentioned earlier, that the Pan Am crew counted taxiways as they passed them, but a third is not mentioned. Yet they had almost reached the fourth taxiway when the collision occurred. The study group has calculated that Clipper 1736 was passing the third left at the time the ATC clearance was being delivered to KLM 4805. In the Pan Am cockpit, someone started to speak, then stopped when KLM asked for their clearance. As the controller delivered the clearance to KLM, the Pan Am crew was silent.

Since they were unfamiliar with Tenerife Airport, and since they knew they could expect the same departure as that given KLM, the Pan Am crew was probably concentrating deeply on the clearance being given. The silence and the Pan Am captain's almost verbatim recollection of the clearance attest to this. This concentration on the aural channel rather than the visual channel, along with the very low visibility may have prevented their seeing taxiway C-3 as they passed.

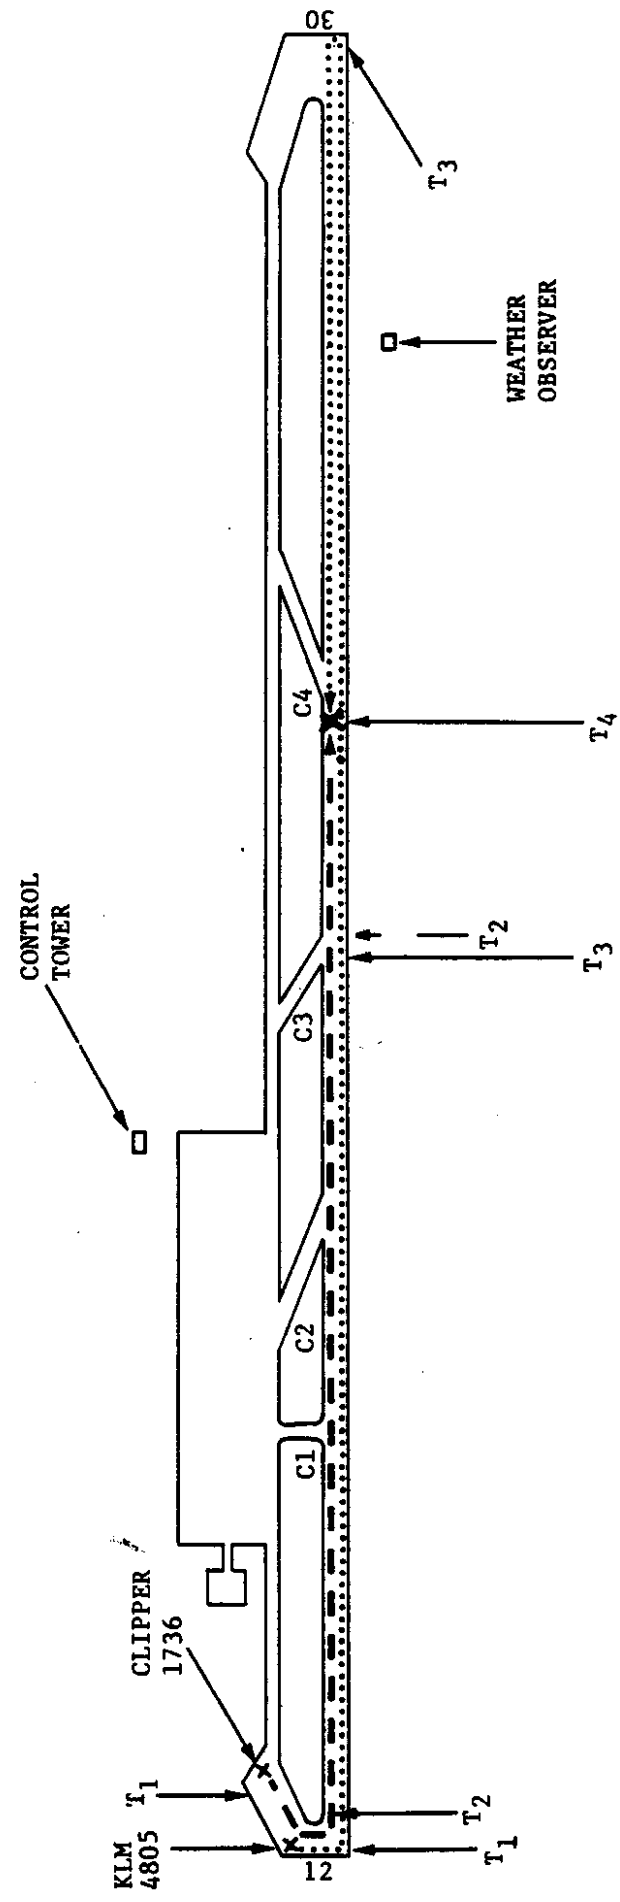
T₃ = 1705:53 (GMT)
 Pan Am passing C3
 KLM receiving ATC clearance

T₄ = 1706:49 (GMT)
 Impact point near C4
