## Survivability of Martinair crash MP595 in Faro

The investigation report describes, conform the ICAO report format, in three paragraphs effects on seats and occupants: 1.12.5 *Cabin interior*, 1.15.1 *Survivability* (see next two pages) and 2.6 *Survivability of the occupants*.

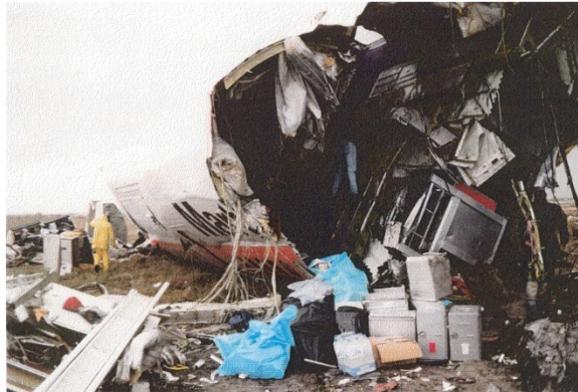
**View of the rolled over and broken off front part of the crashed *Anthony Ruys***
