ACCIDENT REF: 19890108A

Date:	08-Jan-1989	Flight Phase:	Climb
Aircraft:	B737	Location:	Kegworth

DESCRIPTION OF ACCIDENT

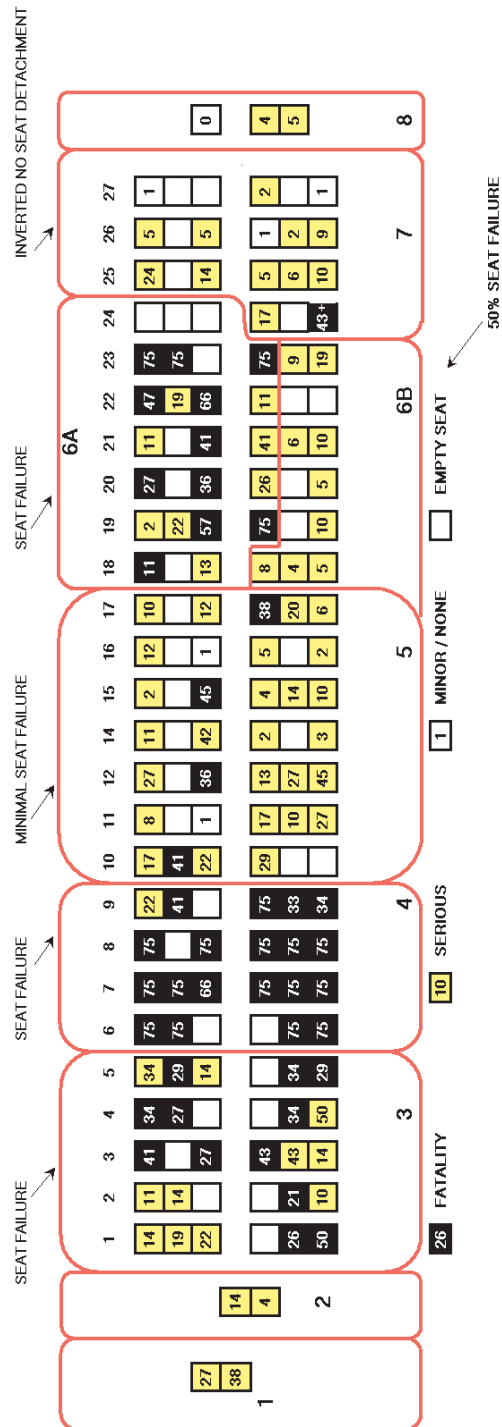
FIGURE A-4. INJURIES SEVERITY SCORES (ISS) AND SCENARIOS

This accident is divided into nine separate scenarios, as shown in figure A-4.

All fatalities were because of impact trauma. The Accident may be divided into nine scenarios as follows:

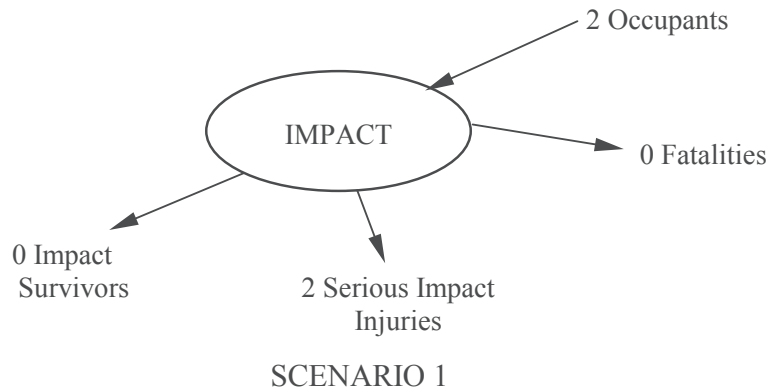
Scenario 1 represents the flight deck area containing two-flight crew, both of whom were seriously injured. The survivability chain for this area is:

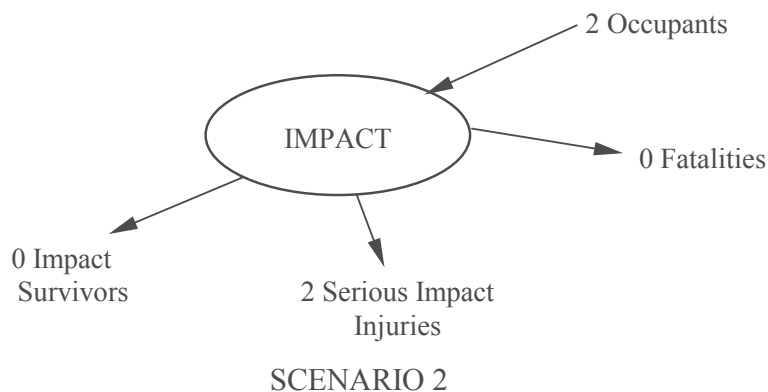
Scenario 2 represents that area of the cabin in which the two forward flight attendants were located, both of whom were seriously injured. The survivability chain for this area is:

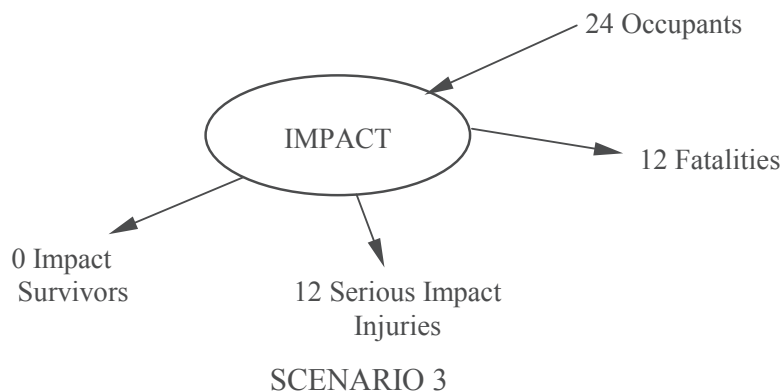
Scenario 3 represents that portion of the passenger cabin between seat rows 1 and 5 inclusive. There were 24 passengers in this area, 12 sustained fatal injuries and 12 were seriously injured. The survivability chain for this area is:

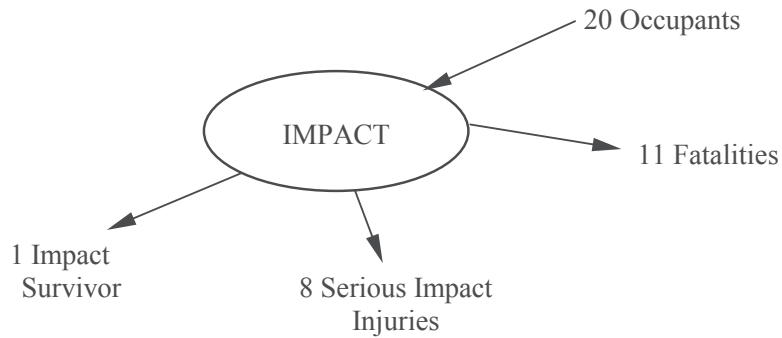
SCENARIO 4

Scenario 4 represents that portion of the passenger cabin between seat rows 6 and 9 inclusive. There were 20 occupants in this area, 11 sustained fatal injuries, and 8 were seriously injured. The survivability chain for this area is:

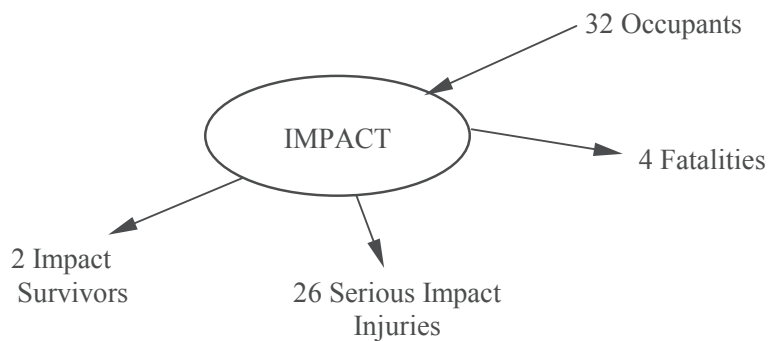
SCENARIO 5

Scenario 5 represents that portion of the passenger cabin between seat rows 10 and 17 inclusive. There were 32 occupants in this area, 4 sustained fatal injuries, and 26 were seriously injured. The survivability chain for this area is:

Based on the accident report data, it is assumed that all the seats in this area remained attached. If the seats had met the full HIC criteria, head, neck, and face injuries may have been substantially reduced. It is assumed that there would be no reduction in the extent of the injuries in seat row 10 due to the degree of disruption immediately in front of the occupants in this area. On this basis, the best improvement that could be expected is that there would be one fatality and three serious injuries in this scenario.

The worst situation is that there would be no improvement in the extent of the injuries sustained due to the severity of the impact. The median assessment is taken as the average of these two extremes.

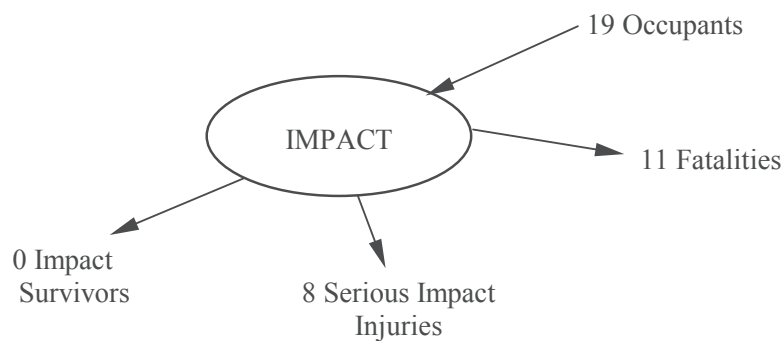
SCENARIO 6A

Scenario 6A represents that portion of the passenger cabin between seat rows 18 to 24 inclusive on the starboard side of the aircraft and the aisle seats on the port side in rows 19 to 23 inclusive. There were 19 occupants in this area, 11 sustained fatal injuries, and eight were seriously injured. The survivability chain for this area is:

Based on the accident report data, it is assumed that seven triple seats in this area remained attached. If the seats had met the full HIC criteria, head, neck, and face injuries may have been substantially reduced. It is assumed that there would be no reduction in the extent of the injuries in seat row 18 due to the degree of disruption immediately in front of the occupants in this area.

It is further assumed that there would be no reduction in the extent of injuries due to the disruption in the starboard seats of rows 22 to 24 inclusive. On this basis, the best improvement that could be expected is that there would be five fatalities in this scenario. It is also feasible that all of the serious injuries, other than those in the four starboard triple-seats of rows 18, 22, 23, and 24, may have sustained minor or no injuries.

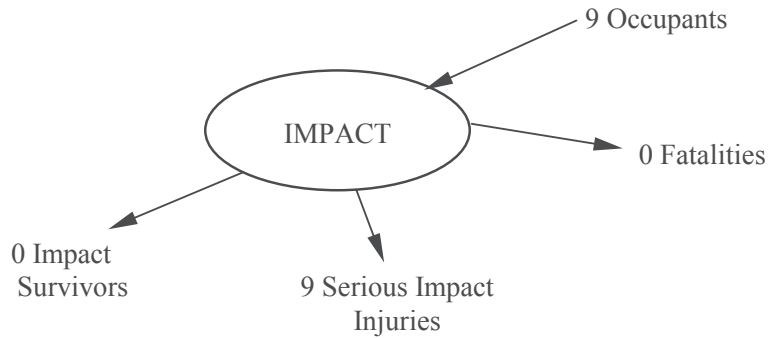
SCENARIO 6B

Scenario 6B represents that portion of the passenger cabin containing the port triple seat in row 18 and the port centre and window seats in rows 18 to 23 inclusive. There were nine occupants in this area all of who were seriously injured. The survivability chain for this area is:

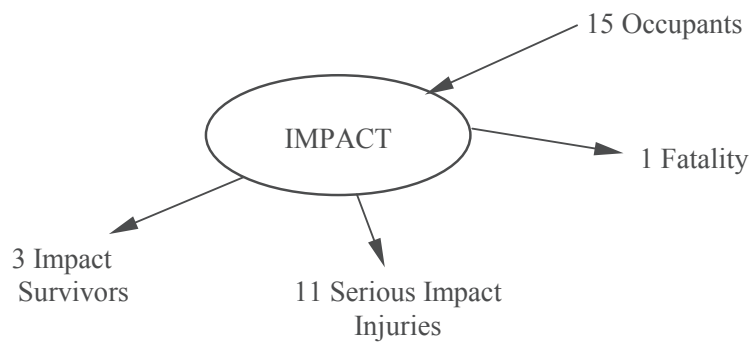
SCENARIO 7

Scenario 7 represents that portion of the passenger cabin from seat rows 25 to 27 on the starboard side and seat rows 24 to 27 on the port side. There were 15 passengers in this area, 1 of whom sustained fatal injuries, and 11 were seriously injured. The survivability chain for this area is:

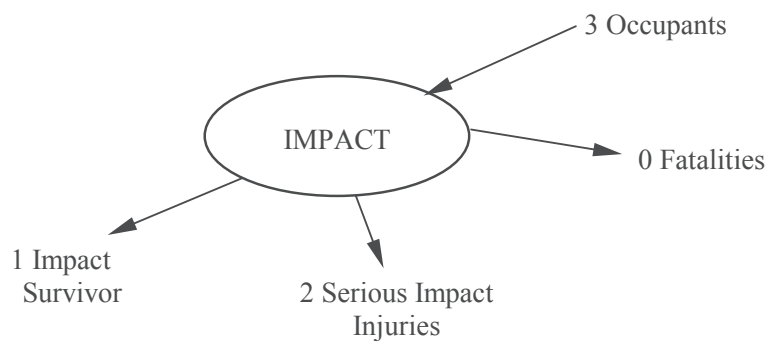
SCENARIO 8

Scenario 8 represents that area of the cabin in which the three aft flight attendants were located, two of who were seriously injured and one survived uninjured. The survivability chain for this area is:
