**AIRCRAFT ACCIDENT REPORT 4/90**

**Air Accidents Investigation Branch**

**Report on the accident to  
Boeing 737-400 G-OBME  
near Kegworth, Leicestershire  
on 8 January 1989**

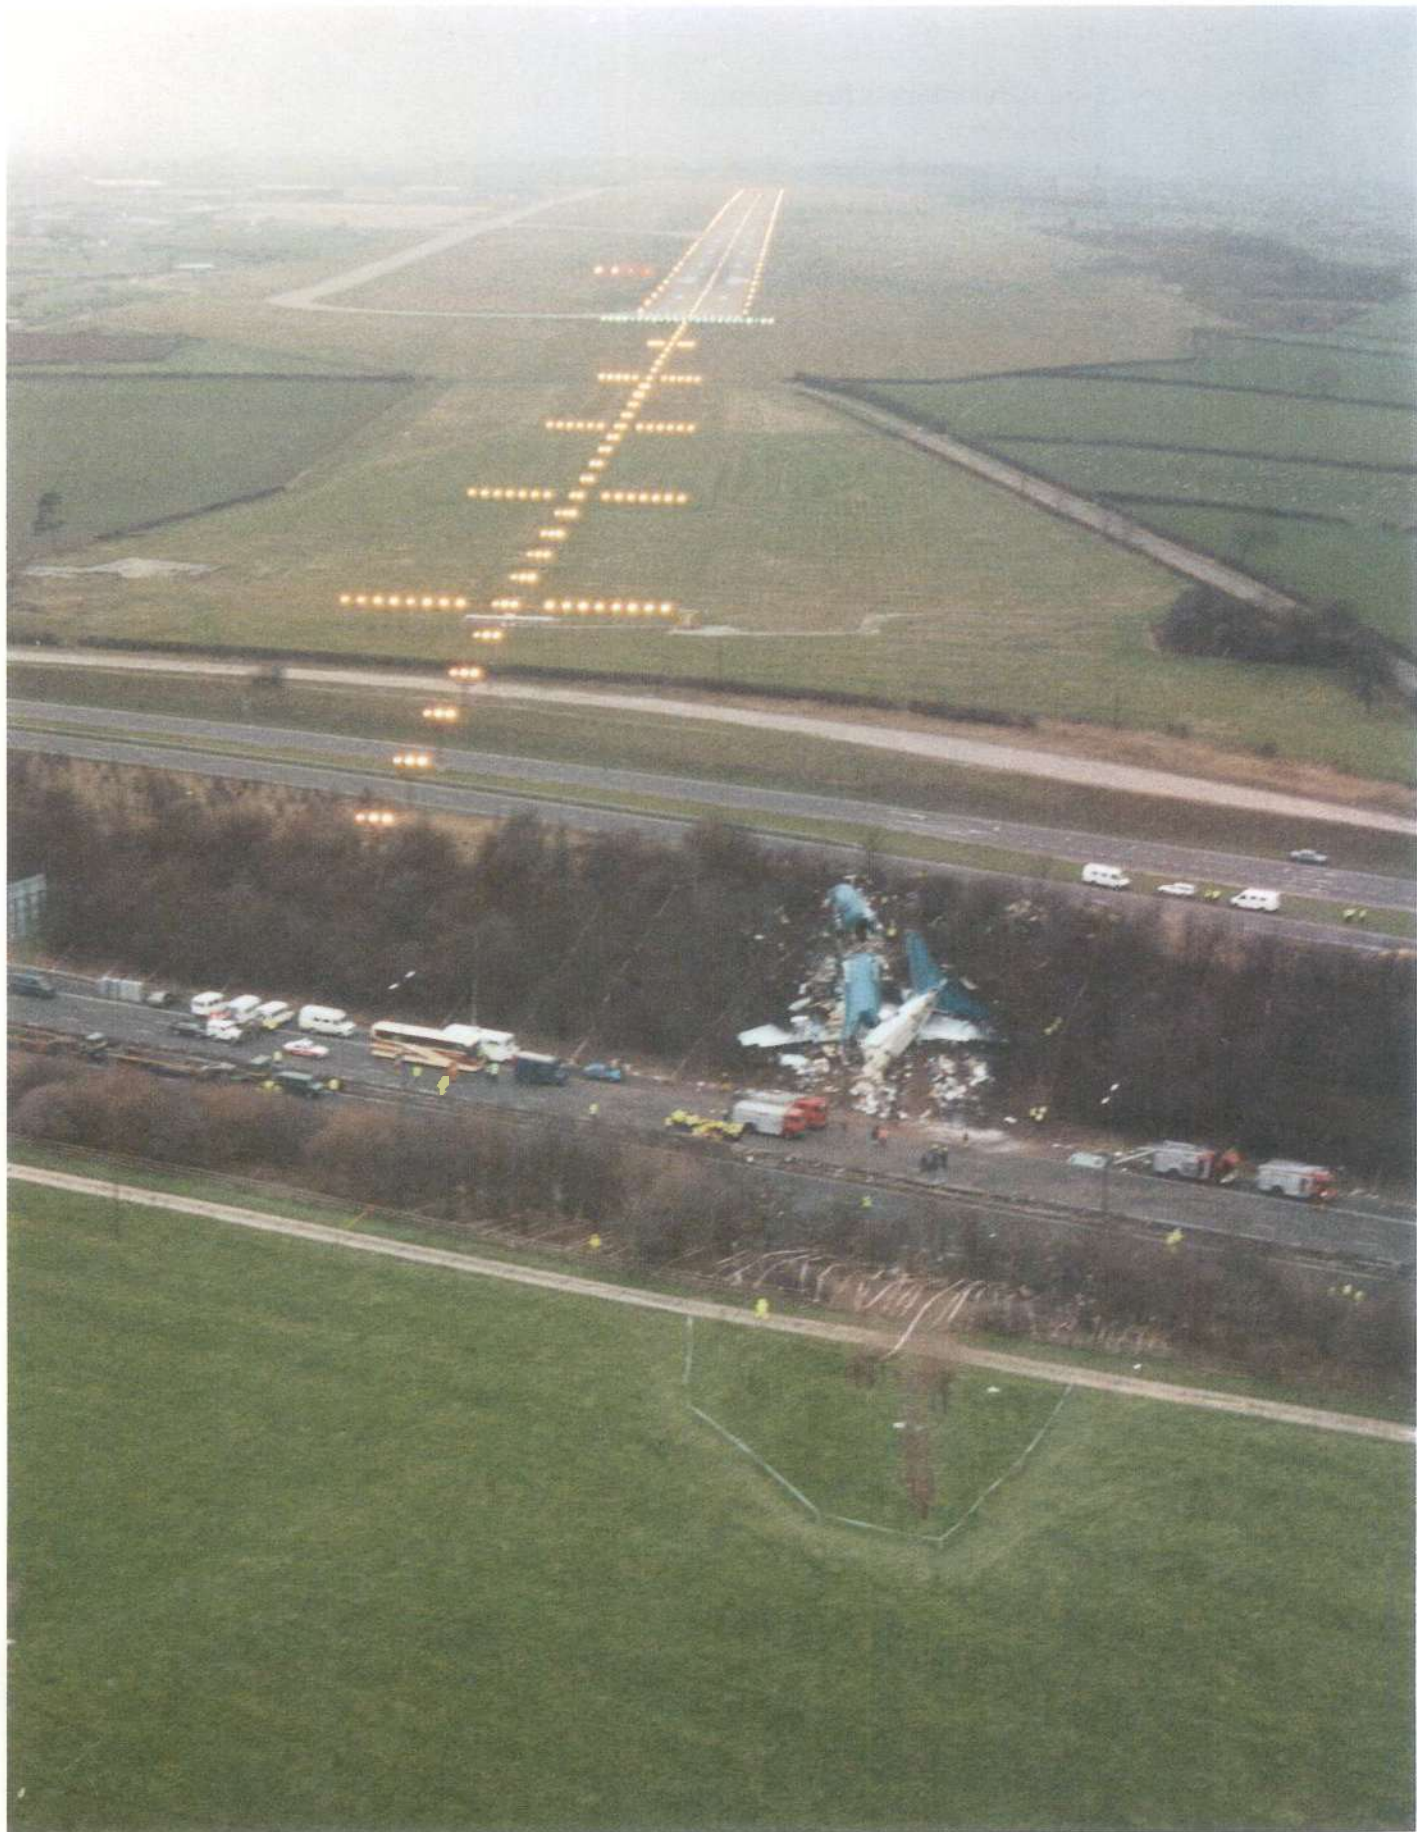
FIG 1: SHOWING CRASH-SITE OF G-OBME

G-OBME suffered severe impact damage and the fuselage broke into 3 main sections (Fig 1). The nose section travelled the greatest distance up the western embankment of the M1, the centre-section remained upright with the wings attached and the tail-section buckled over, and to the right of, that section of fuselage just aft of the wing.
